DNA 4377P-3

PROCEEDINGS OF THE DICE THROW SYMPOSIUM 21-23 JUNE 1977

Volume 3

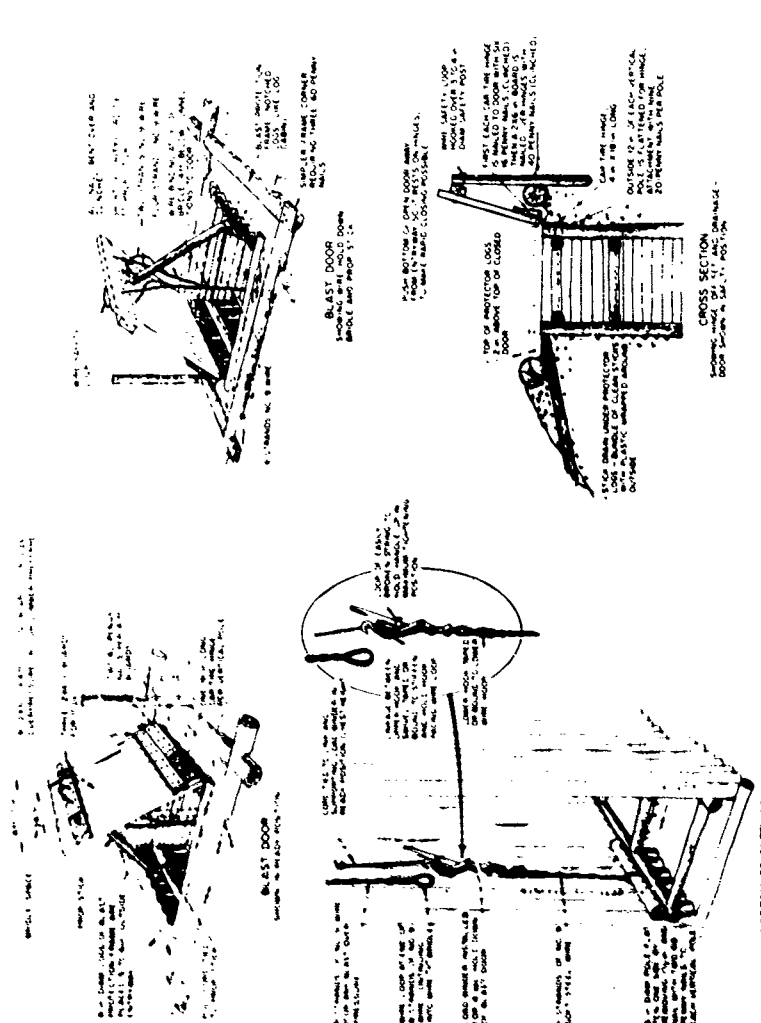
Fig. 4.4. Expedient Blast Door that Can Be Closed and Secured in Four Seconds. The expedient blast doors tested at DICE THROW were all of stronger construction than this door made of boards. This door was damaged but still intact after being subjected to about 17 psi in the main explosion of DNA's MIXED COMPANY EVENT.

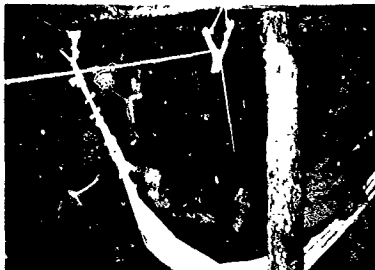
PHOTO
6458-76

Fig. 4.9. Expedient Bedsheet Hammock, Useful to Avoid Severe Shock Effects in a Shelter at High Overpressure Ranges. The man is operating an expedient shelter-ventilating pump via an expedient pulley-equivalent, a greased forked stick suspended on strings.

If a person had been standing on the floor when it was "puffed up" suddenly, possibly his legs could have been injured. To prevent possible injuries due to an intact ceiling moving very rapidly downward and/or the floor moving upward, occupants could recline in expedient bedsheet hammocks¹¹ slung from the upper horizontal brace poles of the main shelter room, as shown in Fig. 4.9.

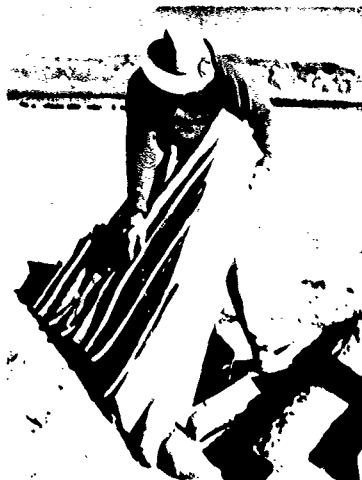
PHOTO
0700-77

Fig. 6.2. Expedient Triangular Blast Door Made of Pine Poles. The auto-tire flap valves over the 1-1/2-in.-wide spaces between the poles were undamaged by the blast effects at the 53-pai over-pressure range. Ground zero was to the left. Blast effects had moved the three connected blast-protector logs, preventing the door from being opened fully.

Figures 6.2 and 6.3 show the triangular blast door on the south end of the shelter, undamaged after the blast. Note that one of the 3 blast-protector logs (the log in the lower left corner of the photograph) has been pushed by the blast up against the hinge-pole of the blast door. The door was undamaged. However, the movement of the earth mound had broken the door-seat pole on which the man's foot is shown resting in Fig. 6.3. Figure 6.4 shows the break more clearly.

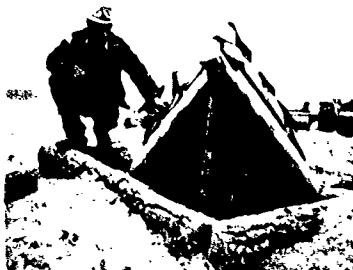
PHOTO
6442-76

Fig. 6.3. View of the Same Triangular Blast Door, Looking Toward Ground Zero. The hinge pole, originally 7-in. in diameter after peeling, had been flattened on its top and back side. The two other poles, 8-in.-diameter, had been flattened on their bottom, top, and inner sides. All three poles were notched and nailed together. Note the slots between the door-covering poles.

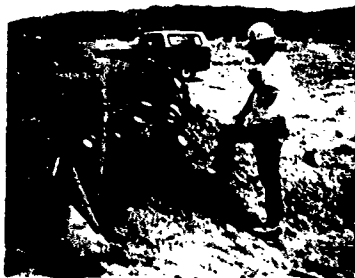
PHOTO
6478-76

The most surprising damage is shown by Figs. 9.6 and 9.7. Obviously, the dry earth "blow" away from the middle of the shelter and toward the two ends of the shelter. Apparently the pressures on the ends of the shelter were decreased as compared to the pressures on the center, both by the lack of reflected overpressures at the ends and the lowering of pressures at the ends caused by Bernoulli effects where the velocities of the blast winds were increased as the winds passed around the ends of the obstructing shelter.

Fig. 9.6. Collapsed Entrance Facing Away from GZ. The blast winds had scoured away most of the covering earth, and the earth had "flowed" away from the center of the shelter, pushing the upper part of the entry in a direction perpendicular to the radius from GZ.

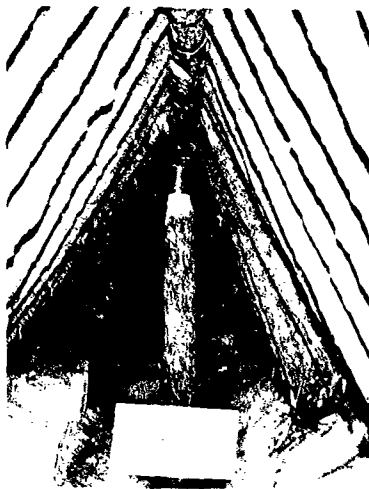
PHOTO
0698-77

Fig. 11.3. Undamaged Interior, Showing Earth Bench on One Side and Roof-Deflection Gauge on Post.

Contrary to our predictions, this lightly constructed shelter, tested closed, was undamaged by blast effects. The undamaged interior is pictured in Figs. 11.3, 11.8 and 11.9.

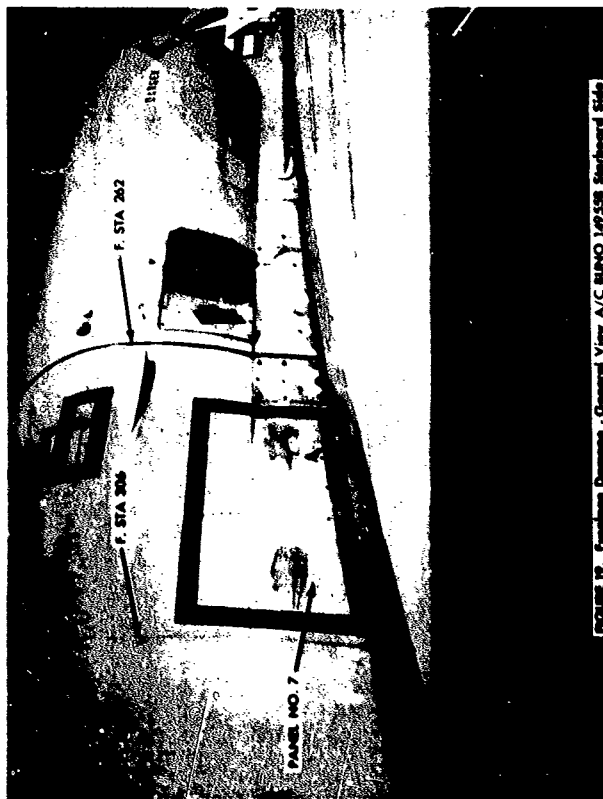
FIGURE 19. Fuelage Damage - General View A/C BUINO 14958 Starboard Side

The posttest inspection of the exterior of this aircraft, which experienced 41.4-kPa (6 psi) peak free-field overpressure, revealed widely scattered local damage on the starboard side (i.e., the side exposed to blast), ranging from buckling of the skin panels to rupture of the skin (Fig. 19), failure of the landing gear doors, and loss of the rudder (Fig. 20). Details of skin buckling are illustrated in Figs. 21 and 22 which show the engine inlet at fuselage STA 175 and the fuselage region aft of STA 400, respectively, where the skin material was 0.81-mm (0.032 in.) thick. Figure 23 shows the fuselage in the region aft of Sta 306 where extensive rivet failures were observed.

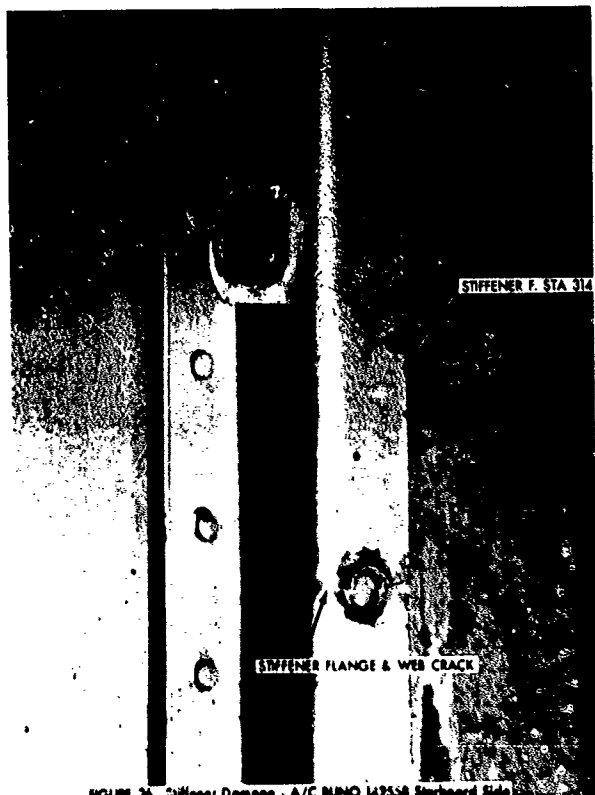
Moderate damage of substructure was noted on the starboard side of the aircraft at the mid-fuselage region between Stations 236 and 342. The damage included sheared fasteners at the joint of such major components as a former and the lower longeron (Fig. 25), buckles and cracks in the stiffener or former flanges (Fig. 26), and a complete failure of a former cross section (Fig. 27). Significantly, fastener holes were invariably present at the crack or rupture locations which implies that considerable strength degradation associated with the presence of a fastener hole may lead to premature failure of the substructure element.

FIGURE 26 Stiffener Damage - A/C BUINO 147558 Starboard Side

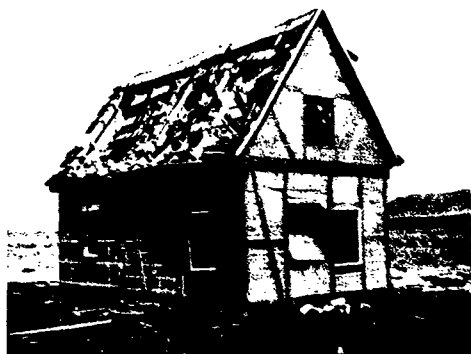
FIGURE 19 POST-SHOT VIEW OF STRUCTURE NO. 2
FROM SOUTHWEST FACHWERK SIDE

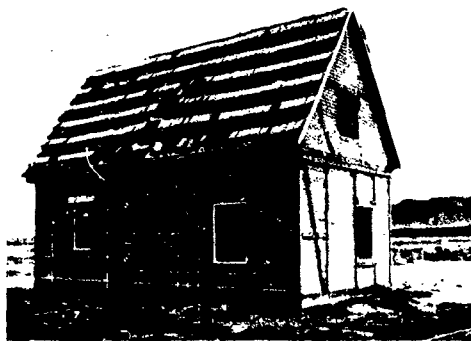
FIGURE 20 POST-SHOT VIEW OF STRUCTURE NO. 3
FROM SOUTHWEST FACHWERK SIDE

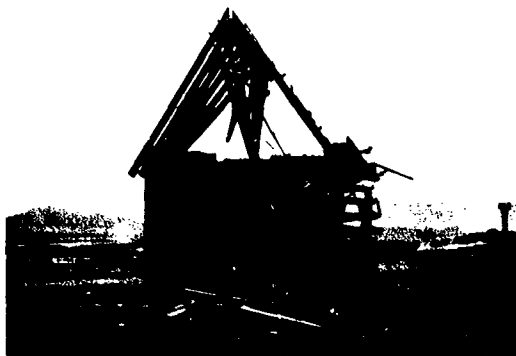
The north side cavity wall was collapsed for a distance of about one-third its length from the front wall as shown in Figure 23. The bottom two courses of CMU, at their intersection with the front wall, were still in place although they had rotated outward and forward about 3/4 in. (Figure 24). Portions of the brick and CMU that were still standing had the Z-ties intact even though the two wythes had rotated about 4 in. outward as a unit (Figure 25). The top course of brick and CMU in the side wall were still bonded to the concrete ceiling slab in the same manner as described for the front wall.

FIGURE 23 PARTIALLY COLLAPSED NORTH SIDE
MASONRY CAVITY WALL STRUCTURE NO. 1

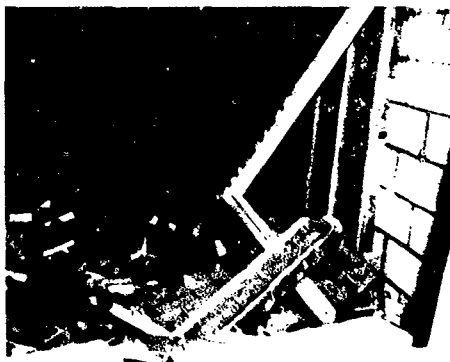
FIGURE 32 INTERIOR DEBRIS FACHWERK TEST CELL STRUCTURE NO. 1

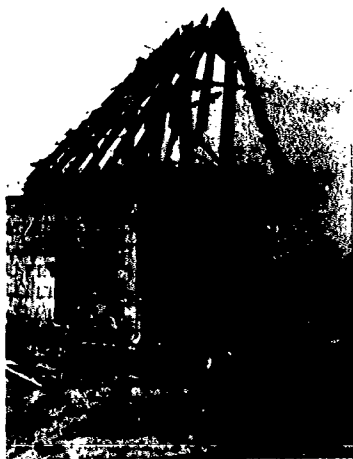
The roof framing over the cavity wall test cell was approximately in position although skewed, as noted in Figure 34. All front rafters, except the one adjacent to the north side cavity wall gable, had experienced typical flexural fractures near the center of the rafter span. The top portions of the rafters were still nailed to the ridge beam, but were hanging downward, and the bottom portions had rotated around the front plate and were resting on top of the reinforced concrete ceiling slab. Figure 34 also shows that the six rear rafters, four ridge beam posts, and the ridge beam above the masonry cavity wall are all structurally intact but somewhat displaced.

FIGURE 34 DAMAGED ROOF FRAMING ABOVE MASONRY
CAVITY WALL TEST CELL STRUCTURE NO. 1

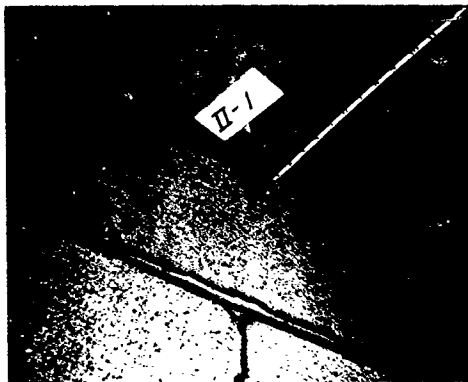
An examination of the interior surface of the CMU indicated that there was more extensive damage to the front cavity wall than was apparent from the cracks in the exterior surface of the brick. The inner face of the top course of CMU above the window had fractured just below the concrete ceiling slab for a horizontal distance of about 5 ft. The CMU below the fracture had a maximum inward permanent displacement of about 1/2 in. near the center of the fracture as can be seen in Figure 38; the displacement decreased to zero near the ends of the fracture. Also, the portion of the block above the fracture plane was still well bonded to the bottom surface of the concrete ceiling slab. The fracture plane on the inner face of the CMU in the front wall of Structure No. 2, which is shown in Figure 38, was identical to that observed in a like location in Structure No. 1 (see Figure 26).

FIGURE 38 FRACTURE IN INNER SURFACE OF CMU IN FRONT CAVITY WALL
JUST BELOW THE CONCRETE CEILING SLAB STRUCTURE NO. 2

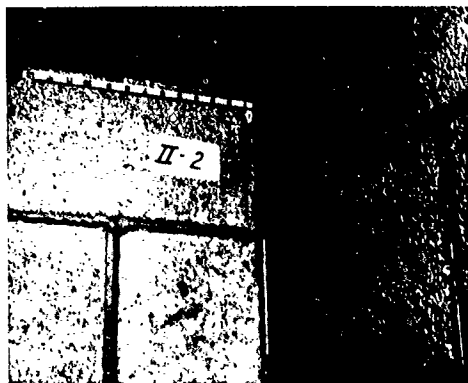
In addition to the fracture above the window, there was also a gap at the intersection of the CMU in the front and side walls. Figure 39 shows that the side wall, on the right in the photograph, has separated and displaced about 1/2 in. away from the front wall; the figure shows the gap in the second course of CMU below the concrete ceiling slab.

FIGURE 39 GAP AT INTERSECTION OF CMU IN FRONT AND SIDE
MASONRY CAVITY WALLS STRUCTURE NO. 2

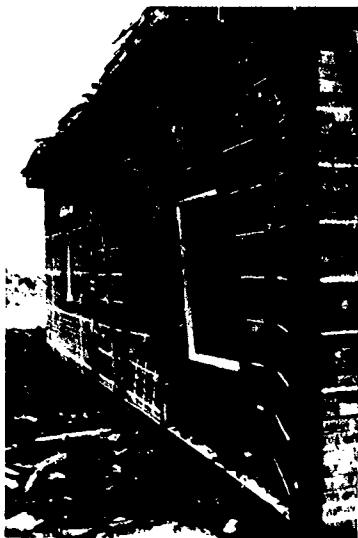
Figures 41 and 42 show in more detail the damage sustained by the west front Fachwerk wall. It is apparent that the bottom plate at the mortise joint to the right of the window fractured, permitting the post and diagonal to displace inward at the bottom with a permanent deflection of about one ft; this deflection probably accounts for the loss of brick below the window. The fracture in the plate is shown graphically in Figure 43, and is a typical failure mode, noted in both Structures Nos. 1 and 2.

The post to the left of the window in Figure 42 split parallel to the grain for its entire height; this is also a typical failure mode often observed in Structure No. 1. The post to the left of the 48-in. wide brick panel, although still in place, sustained a classical bending failure, exhibiting compressive distress on the exterior surface and tensile fracture on the inner surface. In addition, cracking of the inner surface of the bottom plate in the vicinity of the mortise joint for this post indicated

FIGURE 42 OBLIQUE VIEW OF DAMAGED WEST FRONT
FACHWERK WALL STRUCTURE NO. 2

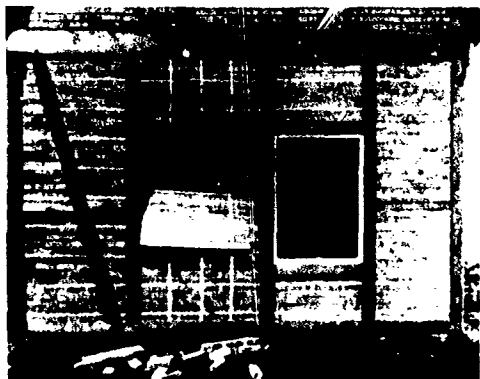
The damage to the south side Fachwerk wall is shown in Figure 46. As can be seen in the figure, the damage to the 48-in. wide brick panel on the side wall is different from that on the front wall in that a large section of the side wall panel, below the collapsed mid-section, is intact although rotated inward at the top. This type of failure mode was probably a result of failing to install one of the masonry-to-timber nails in the right hand post at about the mid-height of the rotated section. The masonry above and below the collapsed portion sustained considerable cracking and spalling of the brick similar to that noted in the front wall panel.

FIGURE 46 DAMAGE TO SOUTH SIDE FACHWERK WALL STRUCTURE NO. 2

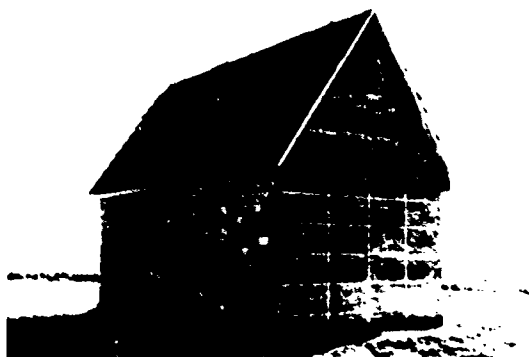
Figures 49 and 51 show the minor damage to the roof tile. Of the 516 tiles on the front roof surface, 20 percent were broken or missing. As noted previously for Structure No. 2, the tile damage for Structure No. 3 was also concentrated in the lower courses on the front roof and the upper courses on the rear roof.

FIGURE 10. DAMAGE TO WEAVER TILE STRUCTURE NO. 3

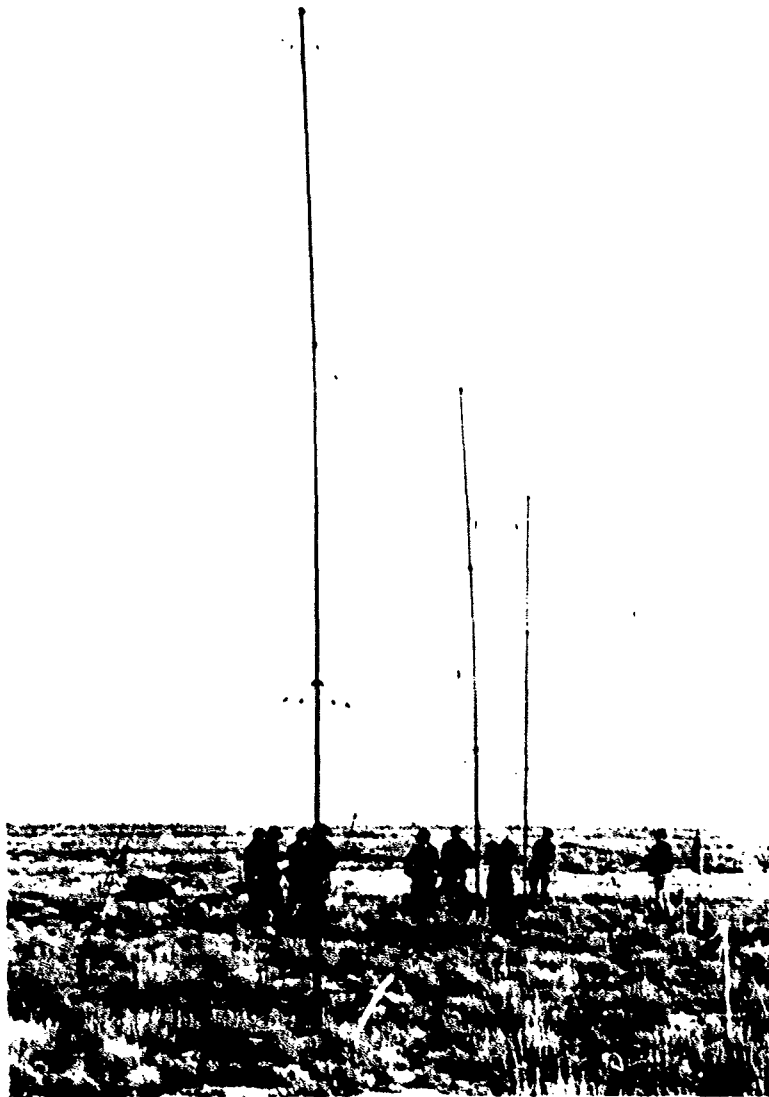
Figure 1. Post detonation view of 1.5 psi experiment site.
